**Re: Duane & Lawrence, Sunnyvale – Addendum to January 31, 2006 Arborist Report**

## TREE SURVEY & ARBORIST REPORT

**Duane & Lawrence  
Sunnyvale, California**

**JANUARY 31, 2006 (revised from 12/15/05 Arborist Report, & 12/20/05 addendum)**

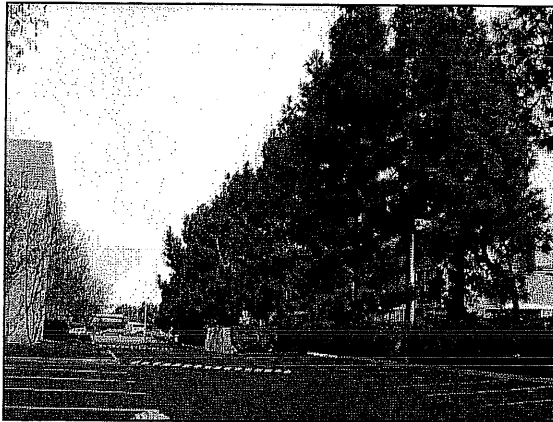
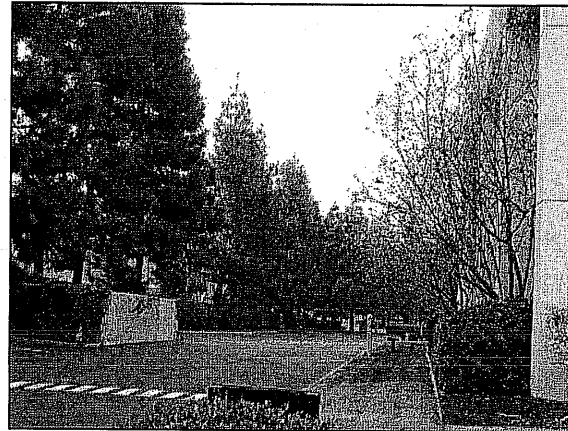
There are some very nice trees on this site, for example the row of **Jacaranda trees along Lawrence Expressway (trees #3 to 9)** and some of the **Canary Island pines that border the south side of the property (trees #1 and 63 through 92)**, although only we should be able to save trees 70 through 84). These pines (see photos below) are mostly in fair to good condition. They are tall trees that function to screen the adjacent apartment buildings to the south of the property. A new parking lot and retail building will be constructed close to these trees, but we should be able to save most of them if they are well protected before and during construction. Unfortunately all of the Jacarandas will have to be removed because there will be a new building in their vicinity. These trees are small enough however, so that they could be transplanted or at possibly salvaged by a tree moving company.
